**GEOTECHNICAL ASSESSMENT REPORT**

**CITY OF CUMMING, GEORGIA  
HIGHWAY 20 SAWNEE TANK SITE  
SLOPE FAILURE  
CUMMING, FORSYTH COUNTY, GEORGIA**

**GeoSystems Project No. 22-2875  
April 5, 2023**

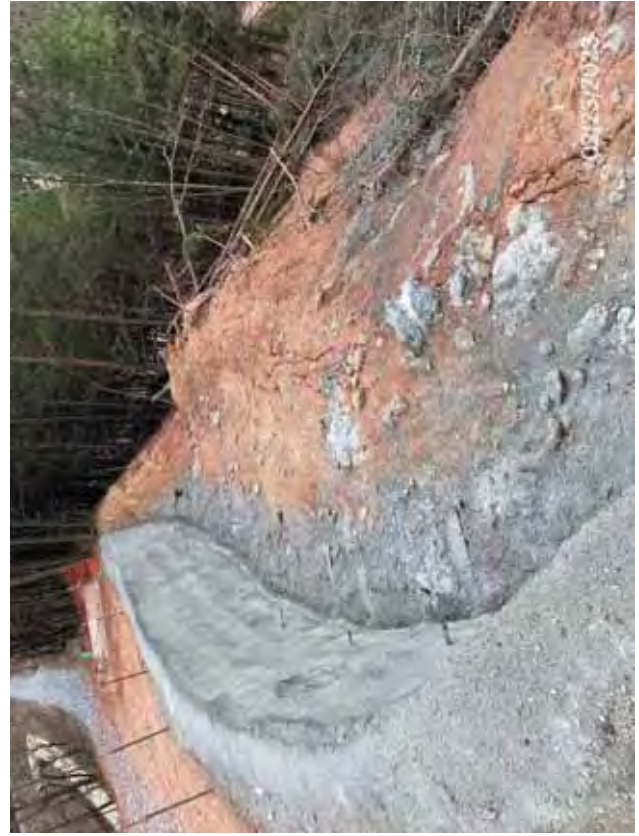
Soil Nail Wall Installed by GSI

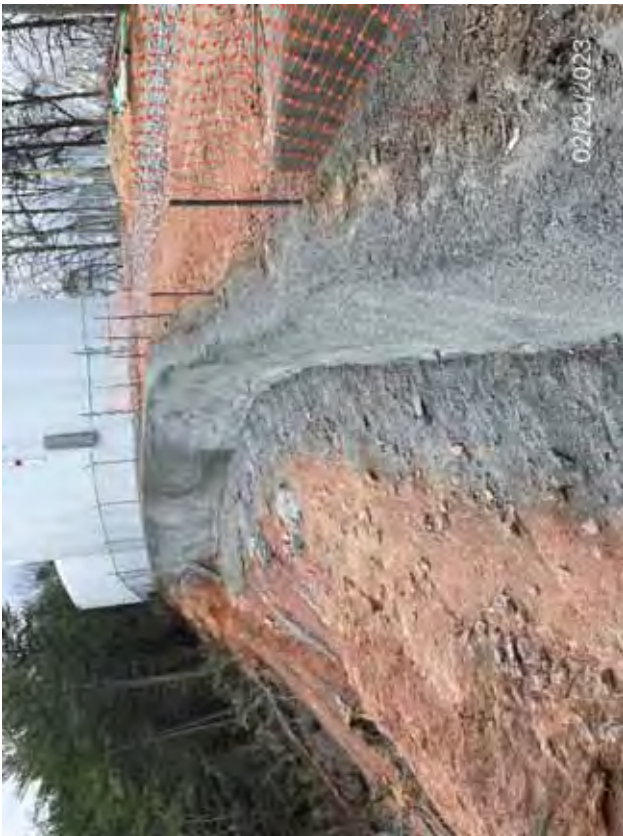
Soil Nail Wall Installed by GSI

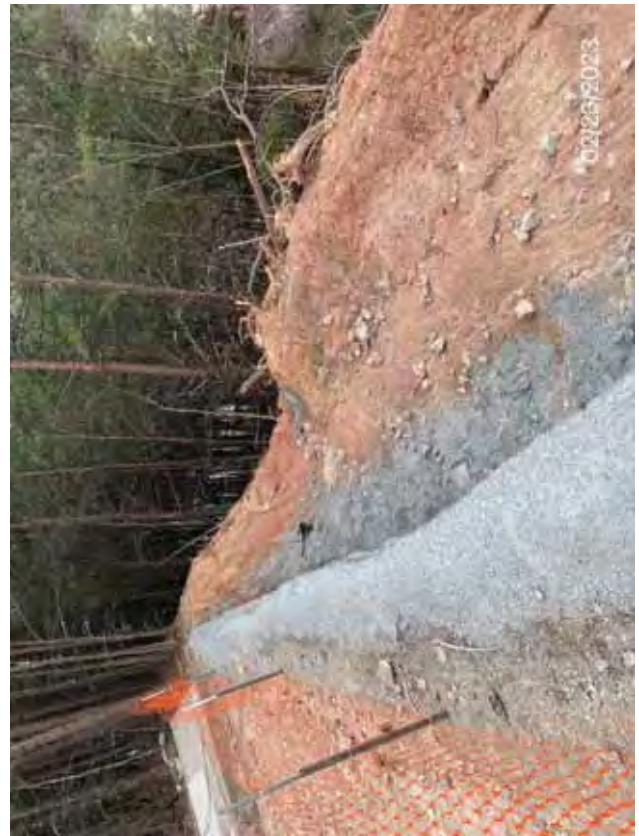
Soil Nail Wall Installed by GSI
